**INDEPENDENT NAVAL EXPERT
CAP. LORENZO COTRONEO
REGISTER OF THE COURT OF MESSINA NO. 42**

**MODULE ASSESSMENT FOR COMMERCIAL, INSURANCE AND NAVIGATION SAFETY
PURPOSES OF USED MOTOR AND SAILING PLEASURE YACHT**

MOTORSAILER " MA DAI "

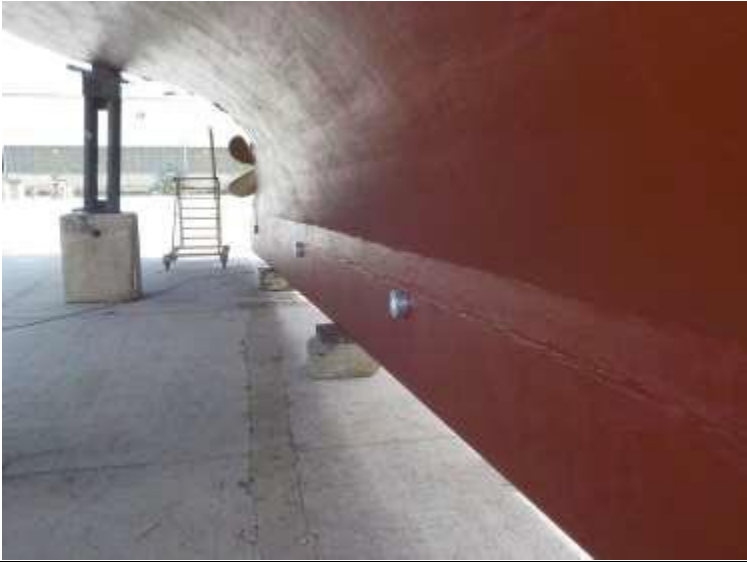
Hull construction materials	<p>Solid mahogany planking; visual examination reveals a homogenous surface, free of rustications or deformations caused by violent impacts with the seabed or semi-submerged objects during navigation. The keel board is intact like the rest of the various submerged sections. Equipped with cathodic protection, which is considered sufficient for its full extent</p>

General conditions living work	No dynamic stress deformation caused by impact of semi-submerged bodies in or stranding is noted.
General conditions dead work	Without any major details. In perfect condition and deformation-free.

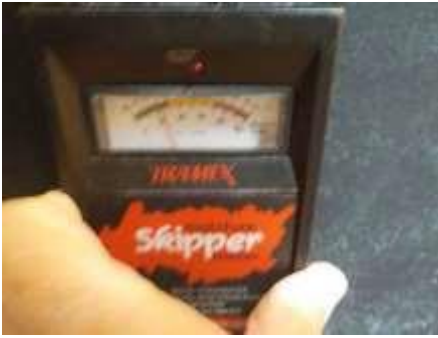
<p>Possible degenerative processes (Osmosis)</p>

<p>No degenerative processes present in the hull. The residual moisture levels of the wood do not raise any concerns. The continuous maintenance to which the unit is subjected also includes annual haul-outs in the yard, for the time needed to lower the moisture levels in the planking of the hull, thus keeping it in excellent condition. The unit is propped ashore and there is no evidence of any deformation near the hull areas subjected to this considerable pressure. The residual moisture measurement carried out with the TRAMEX instrument did not find any values outside the norm</p>
--	---

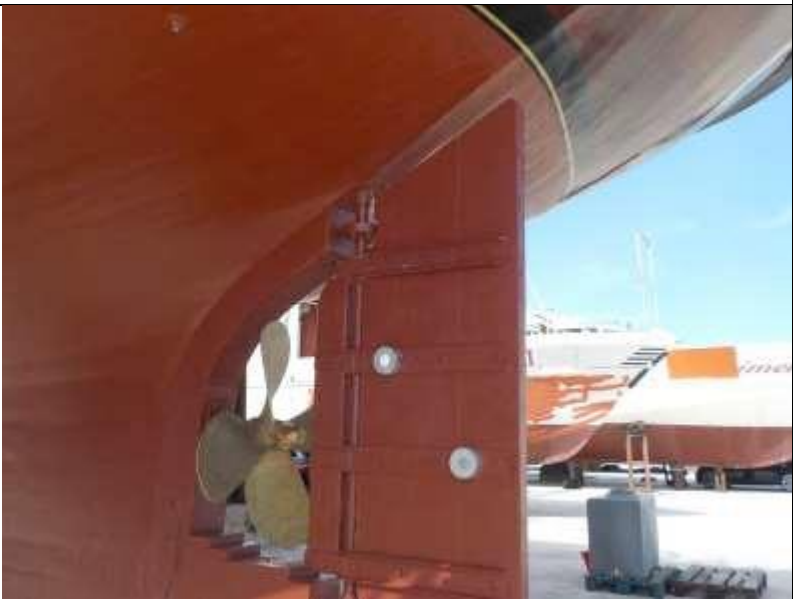
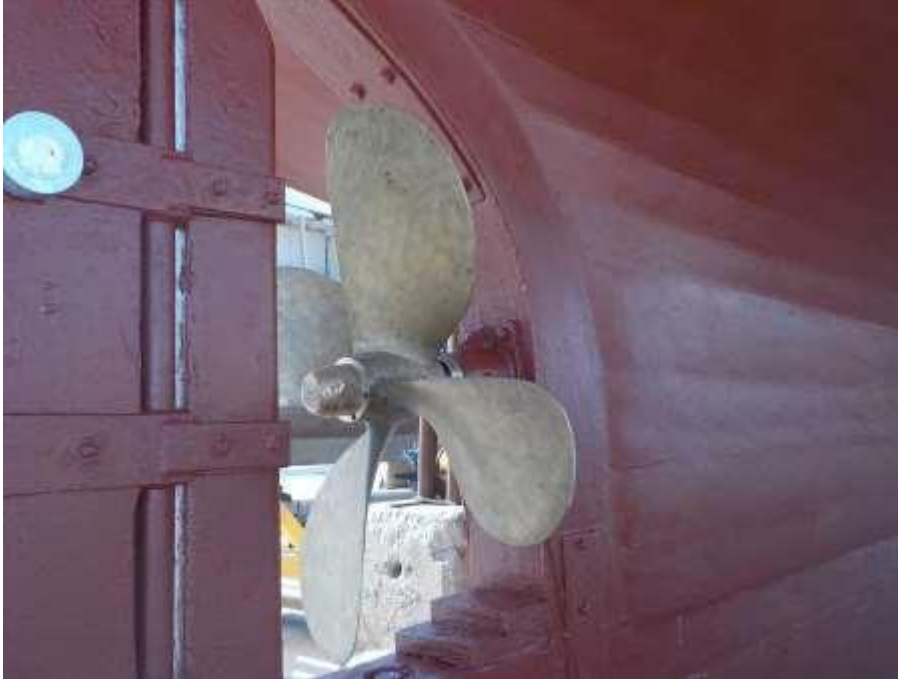
<p>Propulsion system</p>	<p>Inboard inline engine</p>
<p>Organodirection and condition</p>	<p>Wooden rudder with horizontal steel reinforcing bars binding it to the axis of rotation. The context is in perfect condition and well protected with sacrificial anodes.</p>
<p>Elica Massif and Axis hull Propeller holder.</p>	<p>Checked the through-hull bushing in the stern massif and found to be free of slack;</p>
<p>General condition of the propeller and any corrosive processes and forms of cavitation: No cavitation detected; the casting is intact and no deformations can be seen; rustles on the blades and their leading edge on the hub are intact.</p>

Excellent cathodic protection of propulsion and steering systems - spinners, hull and rudder gussets, on all metal sections as well as along the keel protected with steel foil.

Living work found in excellent state of use and maintenance

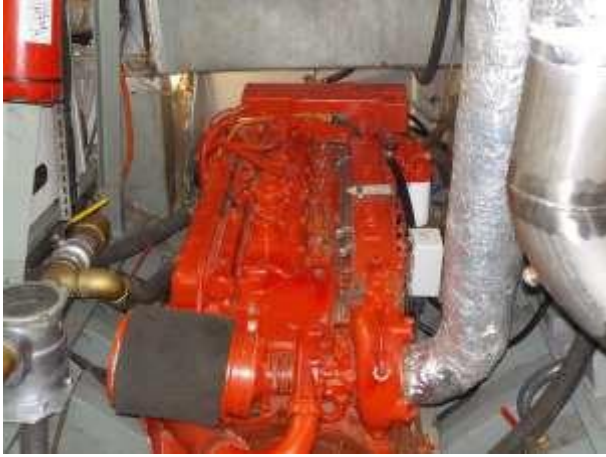
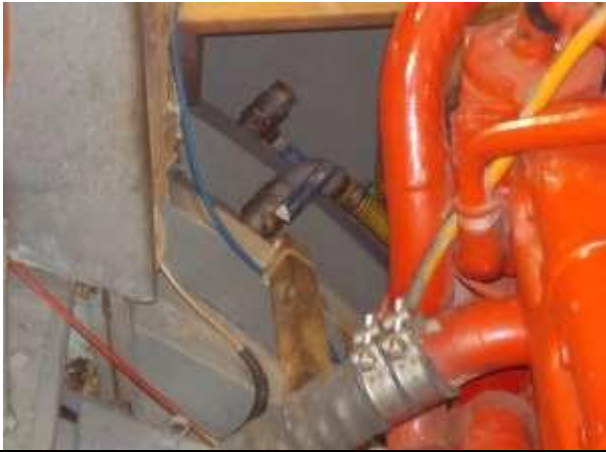
Engine room and bilge cleaning; General engine condition;

The engine room was inspected, and the engine is dry and free of diesel and oil leaks; there are no rusty parts, and all the seals of the cooling system, sea water section, are free of salt residues; the fuel system is equipped with diesel filters on the engine and Racor water-oil separator filters to guarantee engine operation even in the presence of contaminated fuel. All non-metallic hoses comply with ISO 7840 a/1. The external lubrication circuit in insulated copper tubing is watertight and hermetic. The engine bilges are in accordance with standards with a sump for collecting any oil; in its current state perfectly clean.

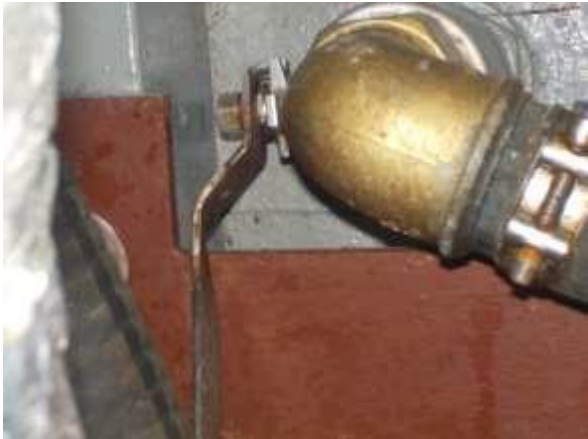
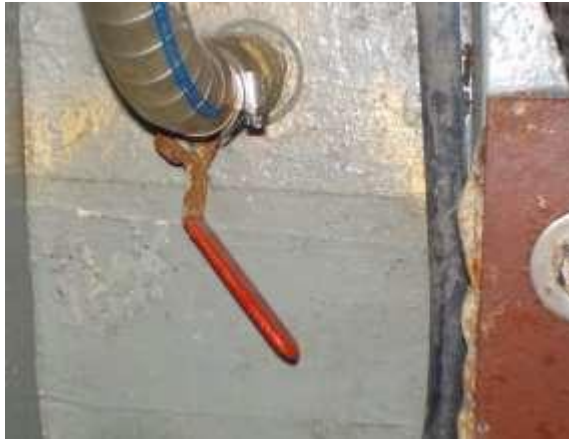
Engine room insulation	Intact;
<p>Condition and condition of main engine sea inlet valves, and sea water filters;</p>

<p>All the hull valves of the various seawater services were tested and found to be efficient in rapid opening and closing manoeuvres without the need for levers or mechanisms that would only contribute to wasting precious time in emergency situations.</p>

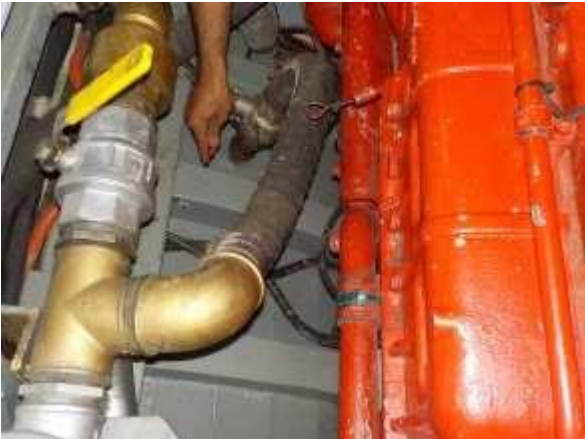
<p>Tested, with opening and closing manoeuvre. Clean and watertight sea water filters; efficient valves.</p>
Checking Fuel Tanks	Located on the side of the engine of the engines, with boarding tubes in accordance with ISO 7840 Class A/1, free of oxidation; no dripping of fuel;
Checking the Fuel Supply Tubes	Intact and of the approved type.

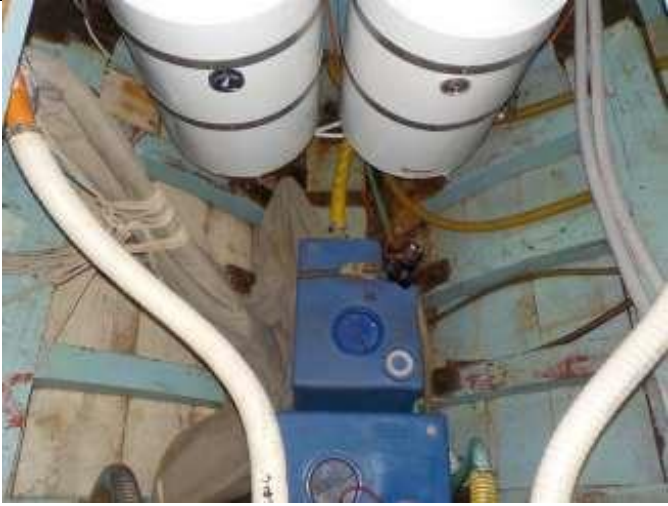
SUPPORT STRUCTURES GOVERNING AND PROPULSION BODIES	
It was verified from the inside of the hull that on the support structures of the following organs (if any): rudder, propeller shafts, support arms, axle grommets, no lesions, cracks, detachments?	Visual inspection; internal structures intact; the longitudinal frames and beams are free of damage;

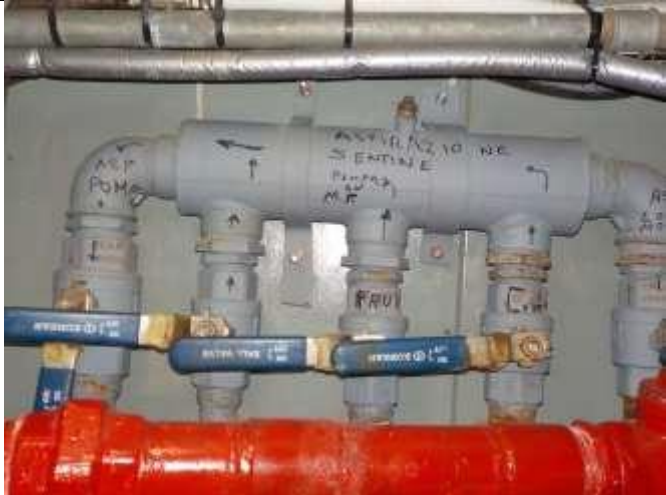
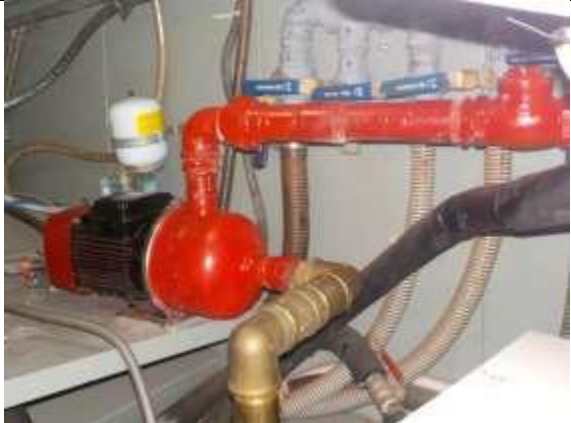
Existence of local mass exhaustion engine on by-pass of the taken sea:	NOT REQUIRED
System efficiency with opening tests and closing valves	Efficient;
Verification of bilge pump discharge systems,	No. 1 submerged pump in the engine room with float switch; No. 1 submersible bilge pump cabins; Emergency hand pump; clarinet subservient to 4 bilge rooms on 24V pump
Positioning of exhausts at report at flotation	In accordance with standards:
Pump flow efficiency	In accordance with standards

24 Volts pump, also serving fire-fighting line.

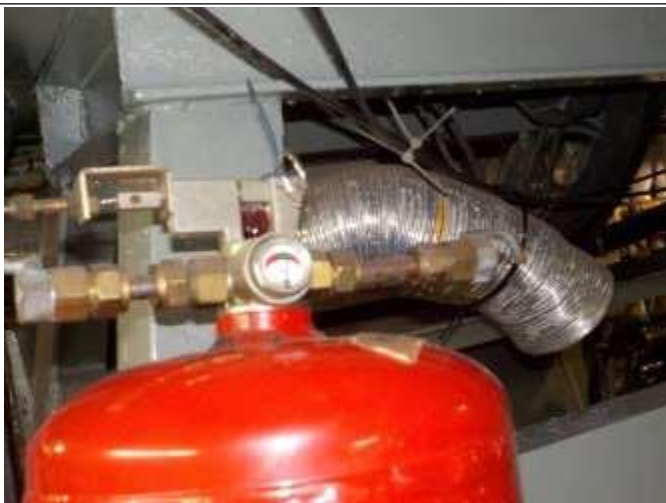
Are portable fire extinguishers in adequate numbers and located in well-accessible places?	YES	N° 3 Powder extinguish ers Kg 1
Are there electrical cables above the hot engine parts?		NO
For <u>diesel-powered</u> EB or EFB engines with a total output of more than 120 kW (including the output of any generators), has the existence of a fixed fire extinguishing system in the engine compartment been verified?	YES

No. 2 local motor dust extinguishers KG 6 kg automatic action and remote activation and mercury valve for automatic activation for temperatures above 75° : serviced and in order until 2023

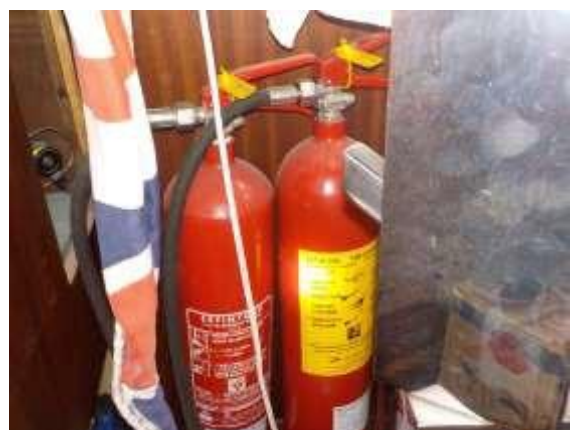
Equipment of portable powder extinguishers Kg 1 in all rooms and near the kitchen.

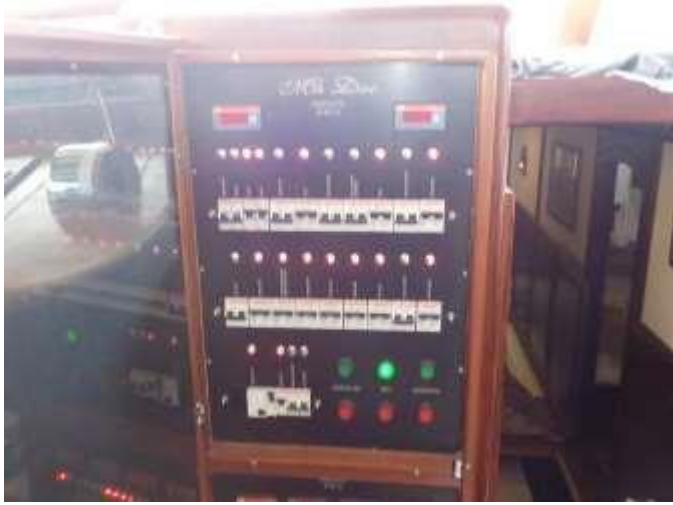
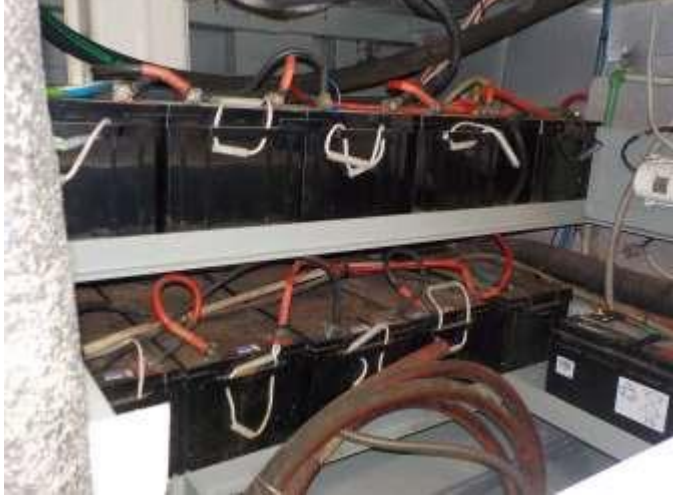
What is the general condition of the electrical installation?	In order
Are the batteries placed in a position protected from the weather?	Yes
Are the batteries securely fastened to prevent electrolyte leakage?	Yes
Are the batteries stored reasonably dry in a high position in relation to the bilge?	Yes
Is the nominal system voltage marked on the panels or is there a voltmeter?	Yes
If present, are the high-voltage and low-voltage switchboards separate?	Yes
Are the battery switches placed in easily accessible positions?	Yes
Has the functionality of the battery switches (battery breakers) been checked?	Yes
Has the efficiency of the installation been verified by means of a functional test?	Yes

<p style="text-align: center;">Regular operation</p> <p style="text-align: center;">General switchboard with 12/24 management separate from the 220V Magnetothermic protection switches on each utility and 220V main switch for charging from dock or generator.</p> <p style="text-align: center;">Separate 220 V management panel with on-board voltage verification instruments and thermal-magnetic circuit breakers to protect consumers.</p>

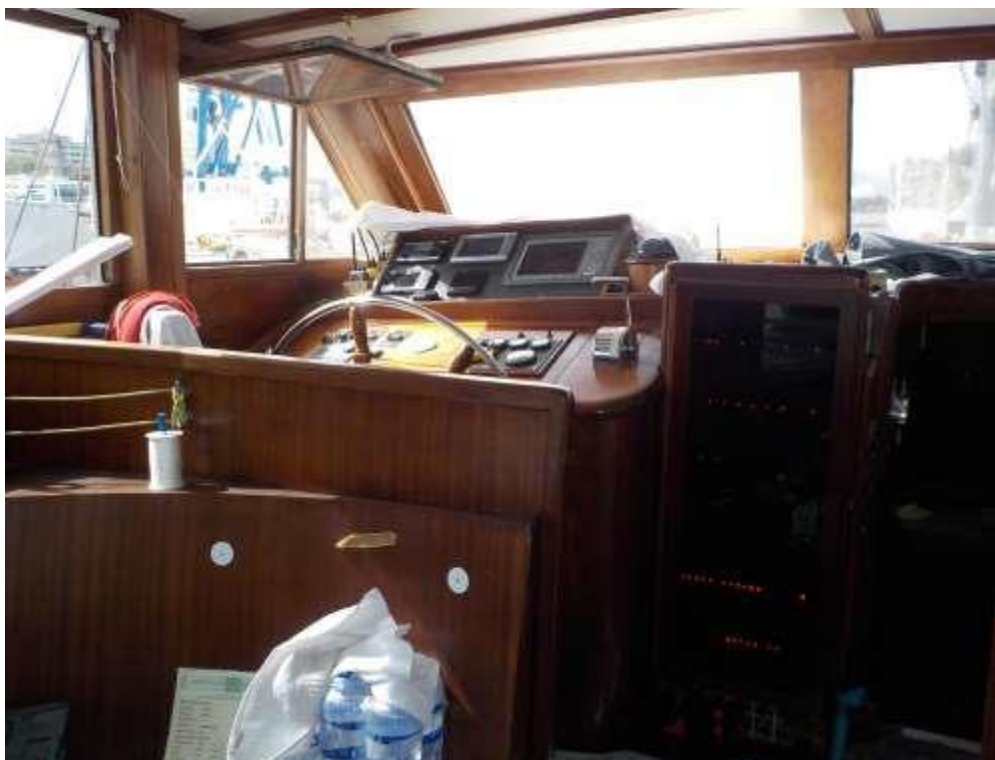
Well-equipped and complete with navigation instruments that although installed in 2006 are still efficient and fully functional, contributing to peace of mind and safe navigation.

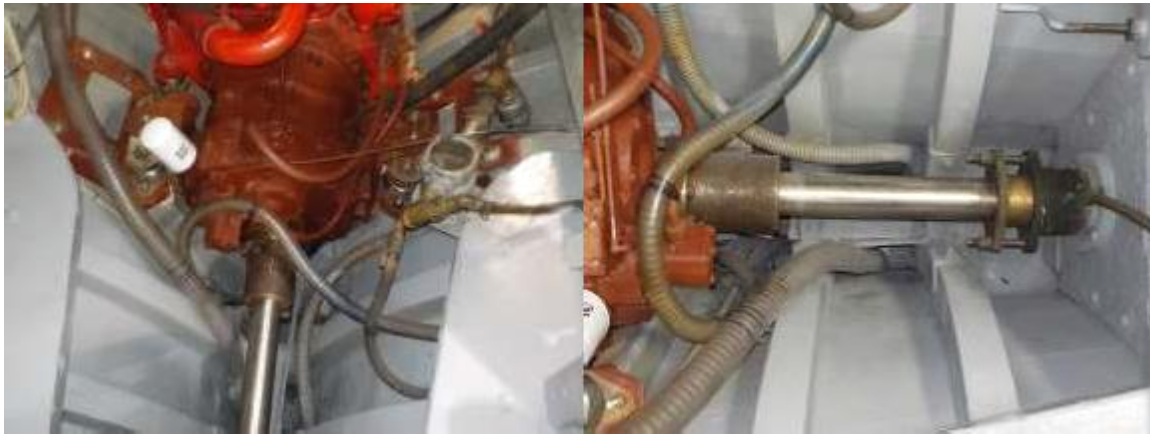
On 24/05/2021 the boat was launched and in the slipway all on-board equipment tests were carried out. Tested the engine and the reverser, with propeller shaft rotation and checking the tightness of the propeller shaft premitreccia and casing.

Having checked the watertightness of the entire hull, no infiltration was noticed, despite the "course" planking that usually lets a slight amount of water seep in after prolonged time on land. No anomalies were found in the operation of the main engine, which was free of smoke and vibrations.
